REPORT OF INVESTIGATION

Fatal Hoisting Accident
February 7, 2013

Affinity Coal Company, LLC
Affinity Mine
Sophia, Raleigh County, WV
I.D. No. 46-08878

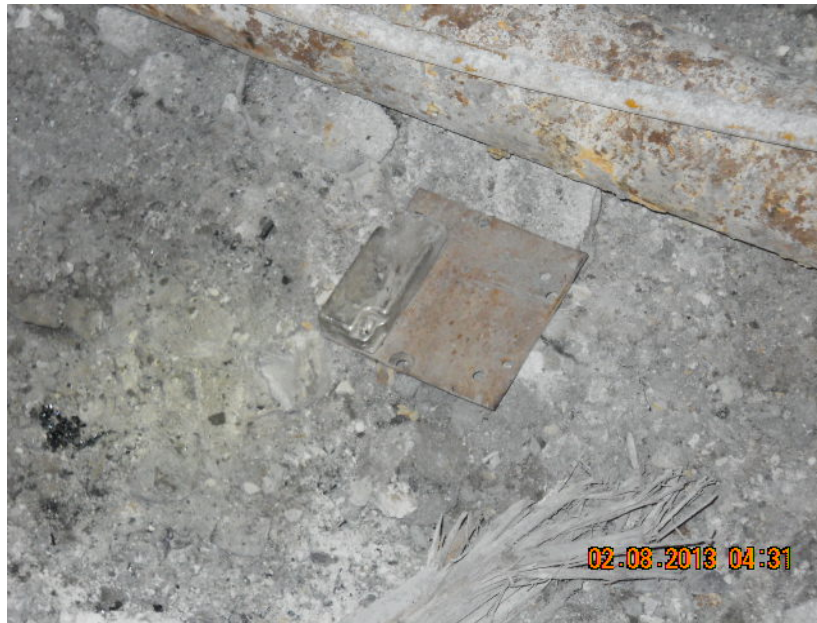
The magnetic actuator of the safety switch for the west side gate and black electrical tape were found lying on the mine floor near the gate post. The West gate was opened and it was physically located approximately 16 feet from where the magnetic actuator was found lying on the mine floor.

When the accident occurred, the magnetic actuator had been taped to the gate sensor switch. The magnetic actuator of the safety switch was untaped and found on the mine floor during the accident investigation (see top photo, Appendix D). Interviews indicated the component was untaped after the accident by maintenance foreman Glenn Paugh, a violation of 30 CFR § 50.12. The MSHA District Manager did not grant an exception to alter the accident scene. Accordingly, a non-contributory citation was issued to the operator for altering the accident scene.

Root Cause: The gate safety switches, provided for the mine level, west side landing gate, were tampered with and were not maintained in a manner to assure the safe operation of the service hoist. The magnetic actuator had been removed from its proper location on the gate and was installed (taped) to the gate sensor switch, which defeated (by-passed) the intended purpose of the safety features and allowed the hoist to operate with the landing gate open. Additionally, tamper resistant hardware, originally provided for the gate switch installation, was not used. Common hex head type screws were used to mount the gate switch, which can be easily removed by anyone using common tools, such as pliers or wrenches, to manipulate or by-pass the functions of the switch.

Safety Switch Actuator on the Ground During Accident Investigation

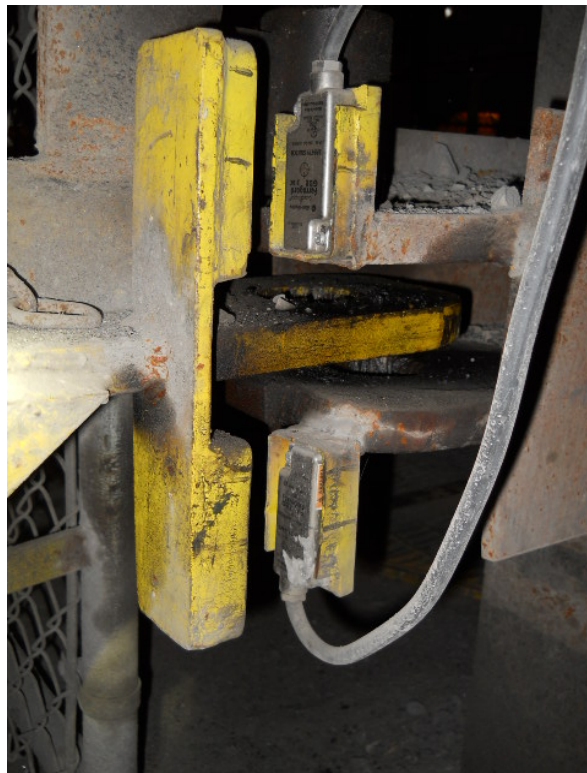
New Safety Switch Actuators Required by MSHA (post accident)
Installed with Tamper Proof Bolts

Safeguard Number: 7224752 requires that all gate safety switches on all hoists at this mine to be installed using tamper resistant mounting fasteners.

Each of the four hoist landing gates, two on the surface and two at mine level, were equipped with two separate gate safety switches installed with tamper resistant hardware. Each gate switch was equipped with a “normally open” and a “normally closed” contact. The switch contacts are monitored by independent safety circuits to improve the safety integrity of the hoist gate electrical system. The gate switches and magnetic actuators were secured in place with tamper resistant mounting hardware, which requires a special tool for removal .
