ACCIDENT FINDINGS REPORT
For
Derailment of CSX Transportation, Inc.'s Unit Crude Oil Train K08014
Transporting Crude Oil for Plains All American
Mount Carbon, West Virginia

October 9, 2015

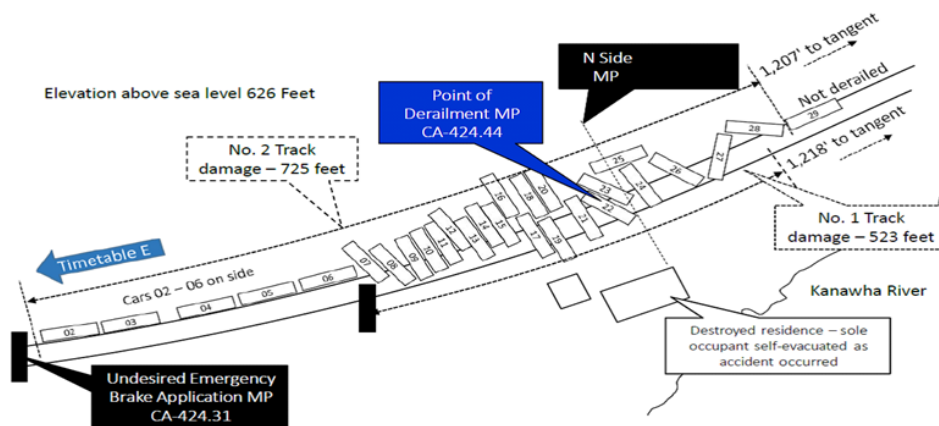
A total of twenty-seven tank cars derailed in the incident. Two tank cars were punctured, released crude oil, ignited, and caught fire. The fire spread quickly, resulting in a pool fire that eventually led to thermal tears in thirteen additional derailed tank cars. Ultimately, twenty-four of the twenty-seven derailed tank cars sustained significant damage in the incident and resulting fire. The fire injured one person (smoke inhalation), destroyed one home and one garage.

CSXT eventually determined the train released 378,000 gallons of crude oil during the incident—much of it lost to atmospheric burn, pool fires and ground absorption.
