National Transportation Safety Board Aviation Accident Final Report

Location:	Big Grand Cay,	Accident Number:	ERA19FA210
Date & Time:	July 4, 2019, 01:53 Local	Registration:	N32CC
Aircraft:	Agusta AW139	Aircraft Damage:	Substantial
Defining Event:	Loss of control in flight	Injuries:	7 Fatal
Flight Conducted Under:	Part 91: General aviation - Personal

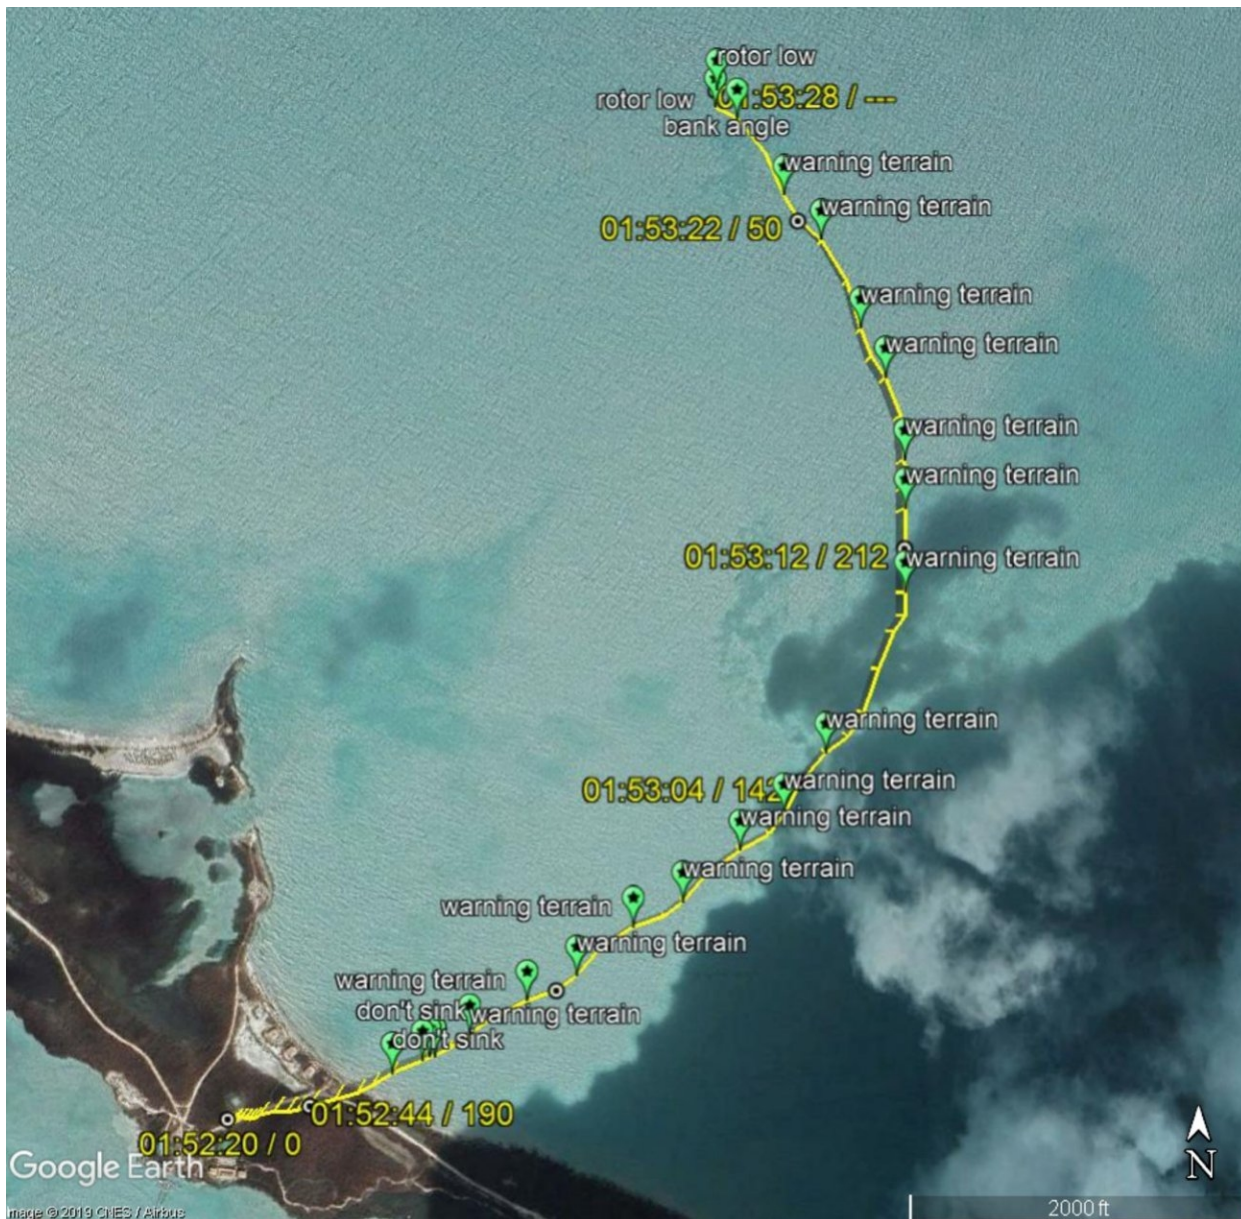
At 0153:13, the helicopter again began to descend, and the SIC stated, "there was a fatal accident in the United Kingdom and this is exactly what happened there." (EGPWS warnings continued through this time.) Two seconds later, with the collective control about 70%, the rate of collective increase slowed as power index (PI) values increased to about 80%. Over the next 8 seconds, the collective position gradually increased to about 75% and PI values increased to about 86%. While descending in a nose-down attitude with the airspeed increasing, the PIC asked the SIC multiple times for headings and once for altitude, but the SIC did not respond. According to an NTSB performance study, the helicopter impacted the water about 0153:22 while in a 7°-nose-down and 12°-left-bank attitude. The CVR recorded no aural master cautions or warning annunciations during the flight. Figure 1 shows the cockpit annunciations recorded on the CVR and select times and altitudes.

Figure 1. Cockpit announcements recorded on CVR with select times and altitudes (Figure contained in the NTSB Performance Study)
