INVESTIGATION REPORT

CHEMICAL SPILL CONTAMINATES PUBLIC WATER SUPPLY IN CHARLESTON, WEST VIRGINIA

FREEDOM INDUSTRIES, INC.
CHARLESTON, WV
JANUARY 9, 2014

REPORT NO. 2014-01-I-WV
SEPTEMBER 2016

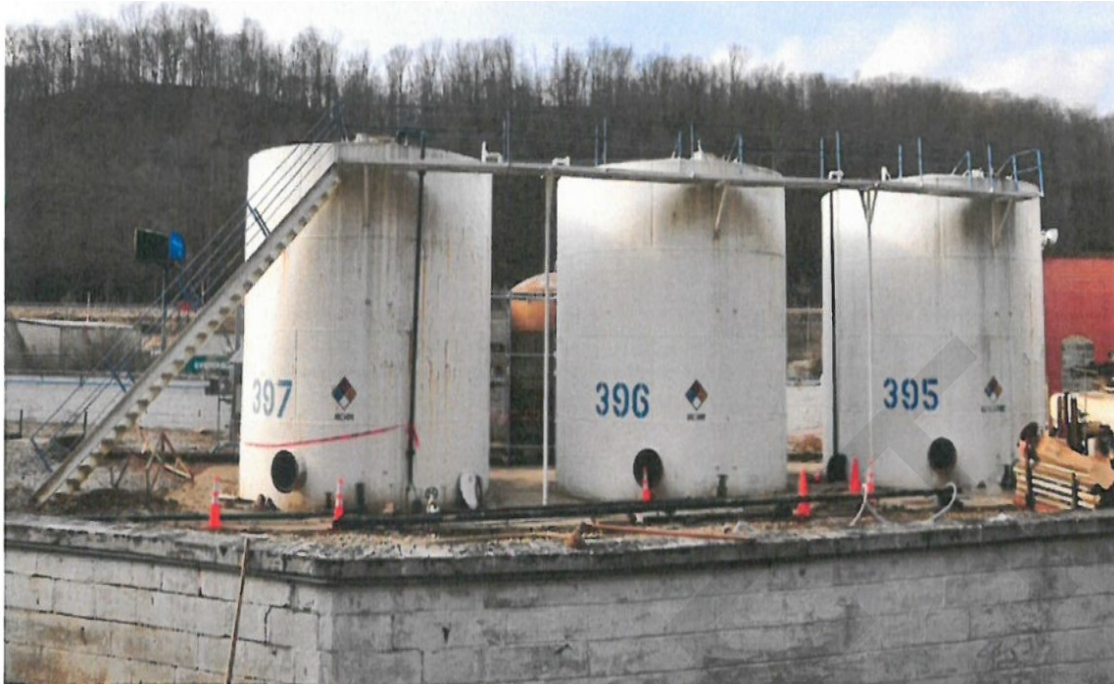
Figure 4. MCHM- and PPH, stripped-containing tanks at Freedom post-incident. (Source: CSB)

Tanks 395, 396 and 397 were 20 feet in diameter by 20 feet tall. The tanks had a lap-riveted⁴⁴ shell, cone roof and a 1/4-inch lap-welded⁴⁵ bottom. Tank 397 was a blend tank that was used to mix MCHM and PPH, stripped to produce a product known as ShurFlot 944.⁴⁶ The final product was stored in tanks 396 and 397 as well as in totes for sale (Figure 5).

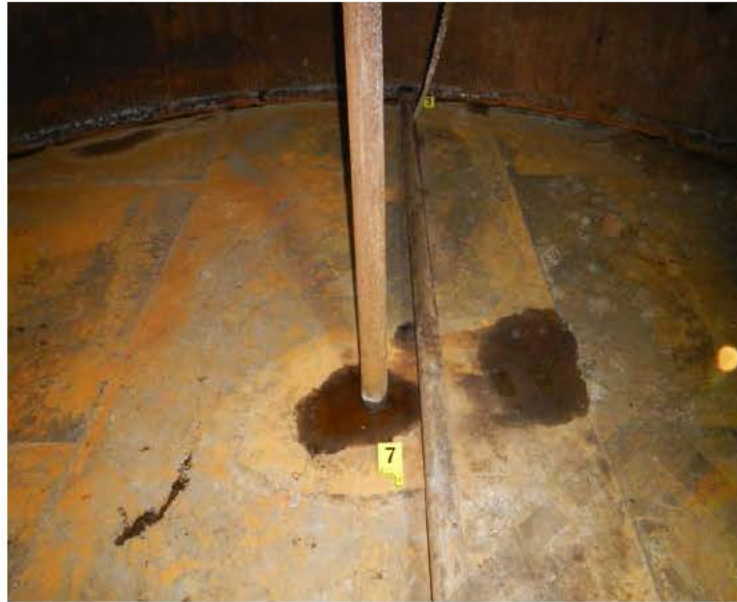
Figure 16. Retrofitted welded bottom of tank 396 (inside of tank). (Source: CSB)

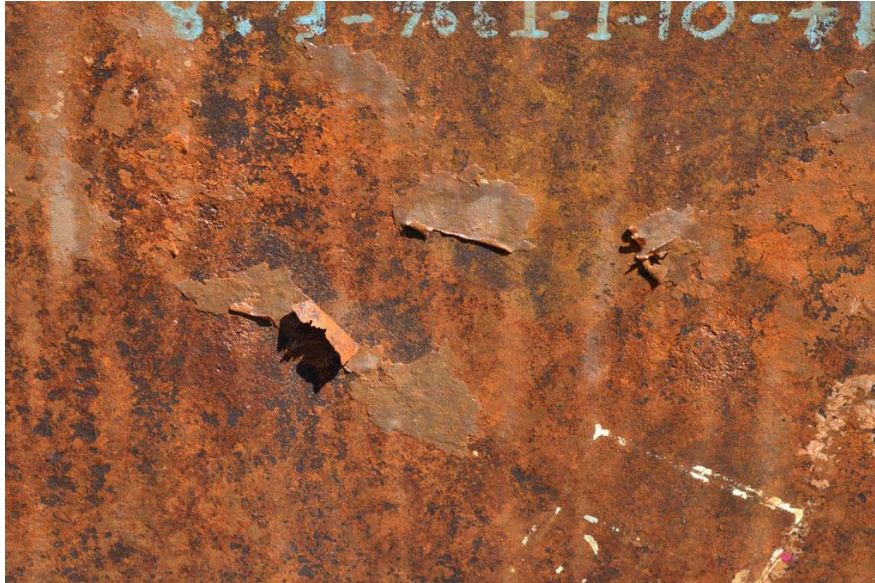
During the initial examinations prior to dismantling tank 396, inspectors noticed remnants of what could have been a flexible organic liner or patch, adhered to the interior surface of the tank floor, likely applied sometime before the leak occurred (Figure 18). Analytical testing determined that the chemical composition of the material was PVA.

Figure 18. Remnants of coating on interior tank floor. (Source: CSB)

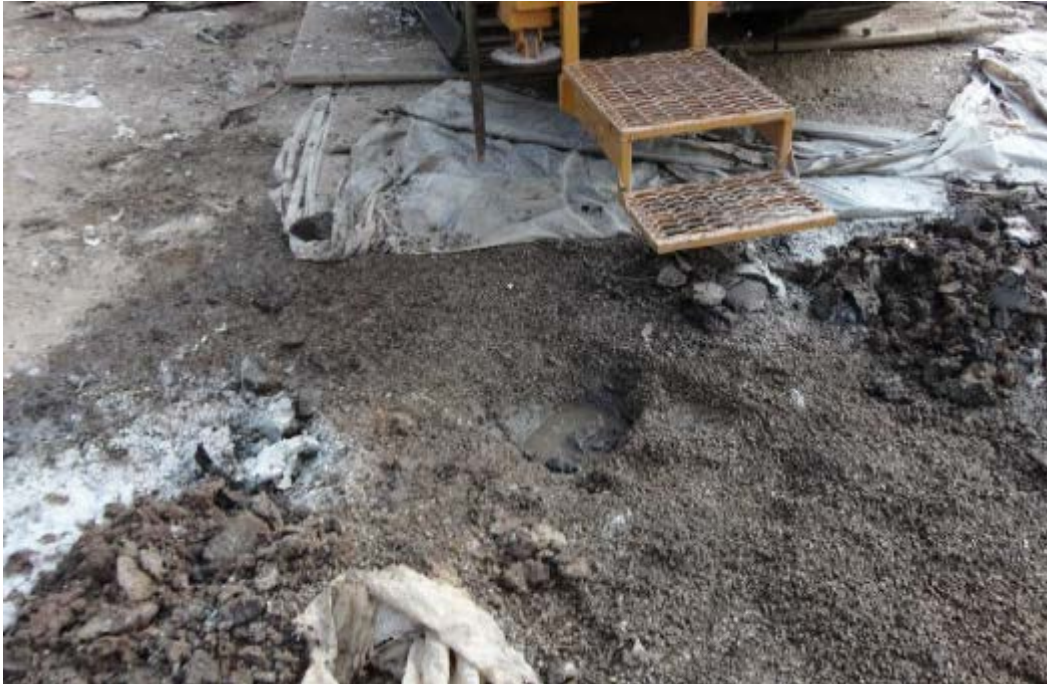
Figure 20. Gravel base under tank 396 and other MCHM tanks. (Source: Terracon)

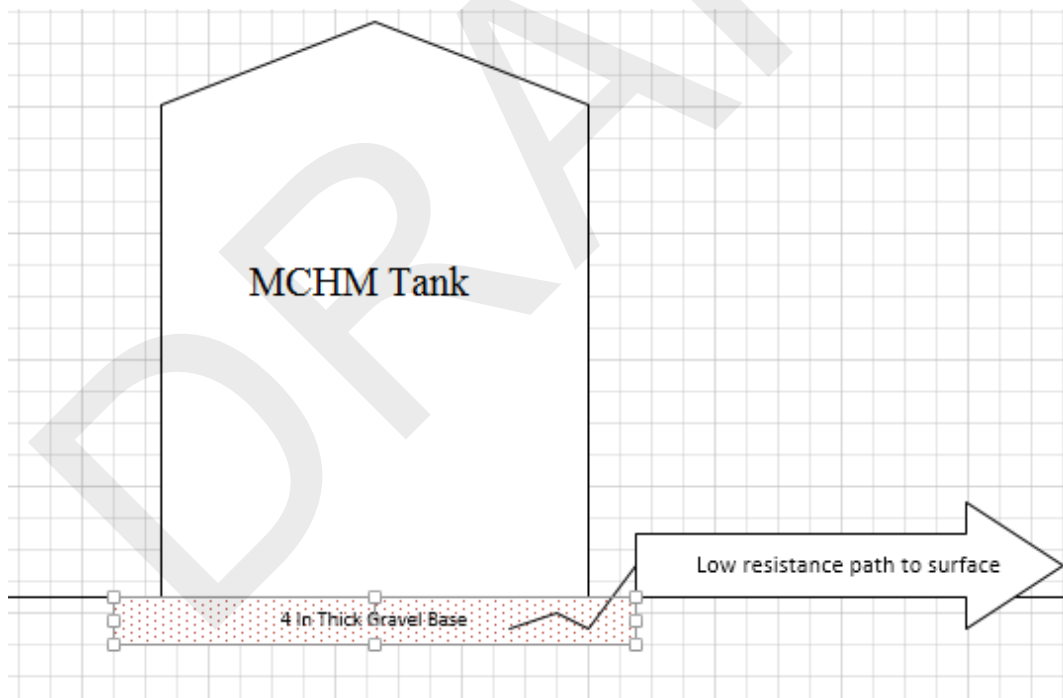
Figure 22. Low resistance flow path provided by gravel base. (Source: CSB)

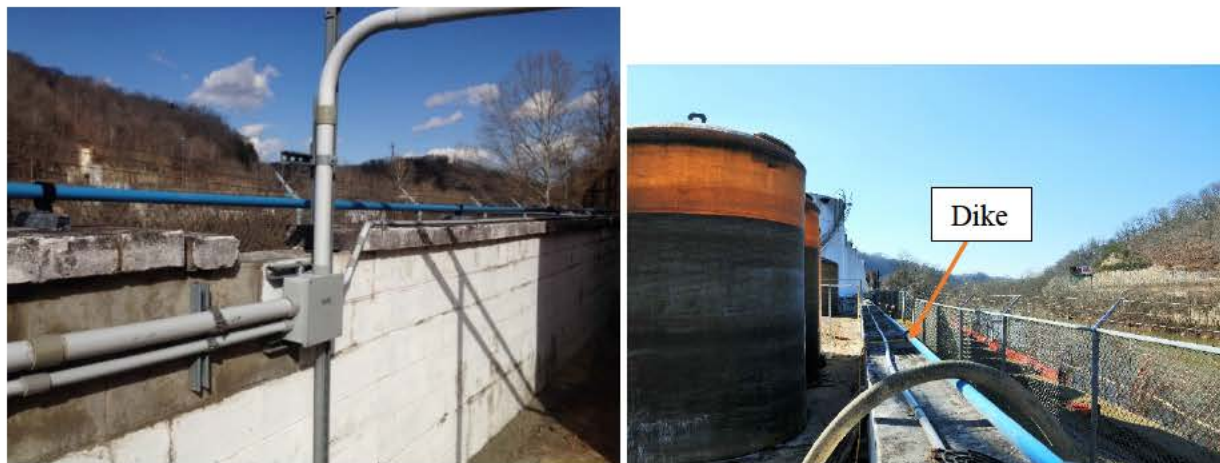
Figure 23. View from inside the dike wall facing the Elk River of the concrete block walls with no reinforcement (Left); dike wall along the tank farm parallel to the Elk River (Right). (Source: CSB)

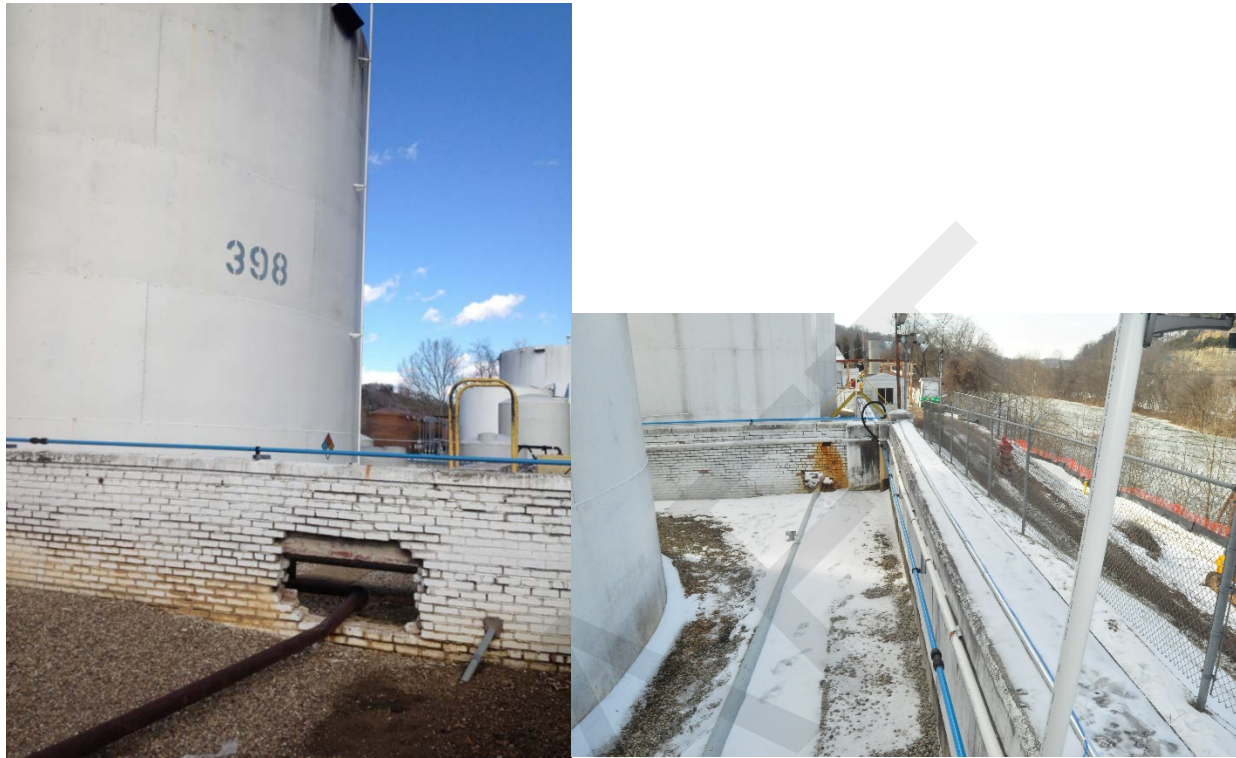
addition, although concrete caps were used around the top of the dike walls, many of these caps were missing or had deteriorated, which allowed for rainwater or other elements to infiltrate the walls.

Figure 24. The dike walls that surrounded the tank farms were in poor condition. (Source: CSB)

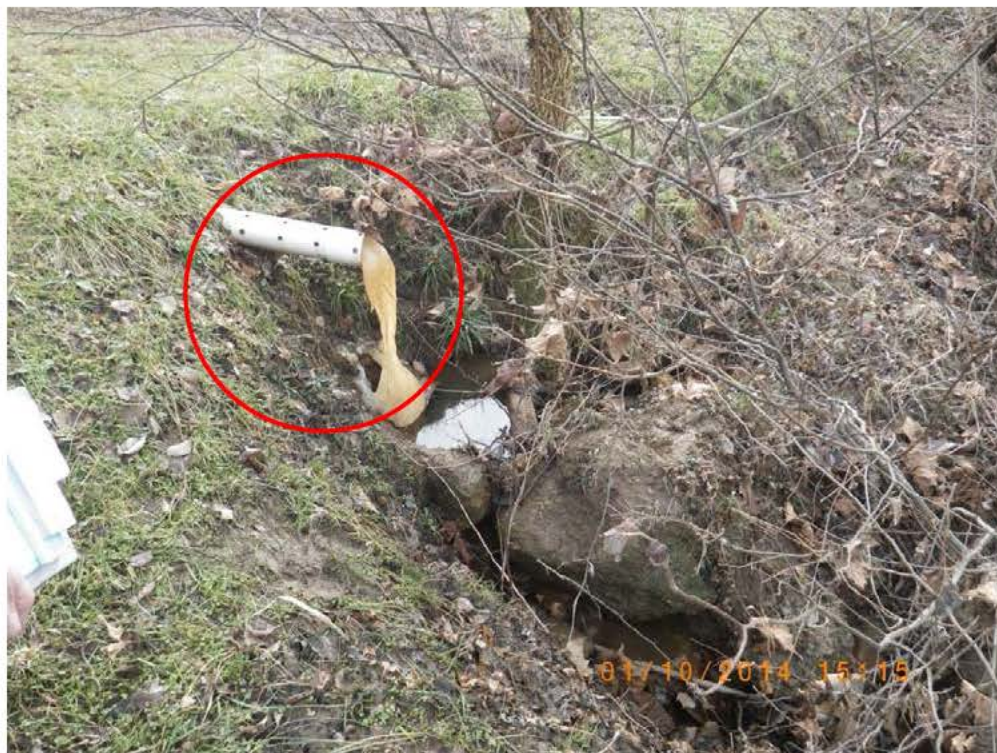
Figure 25. Ice-filled oil/water separator discharge pipe into the Elk River. (Source: WVDEP)

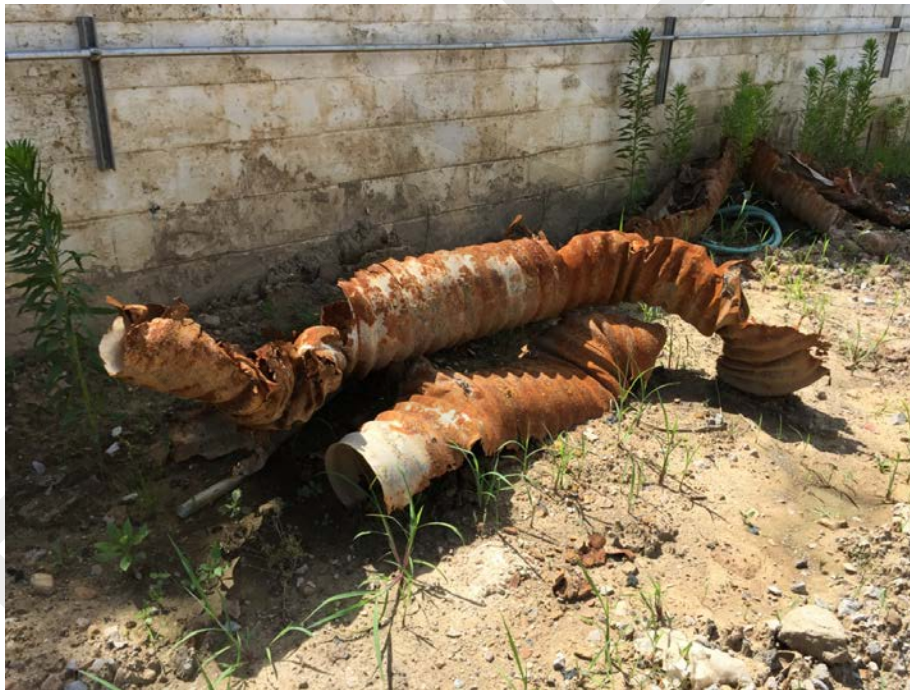
Figure 28. Photo taken on June 15, 2015, of remnants of the culvert that ran between tanks 394 and 395 beneath the site. (Source: CSB)

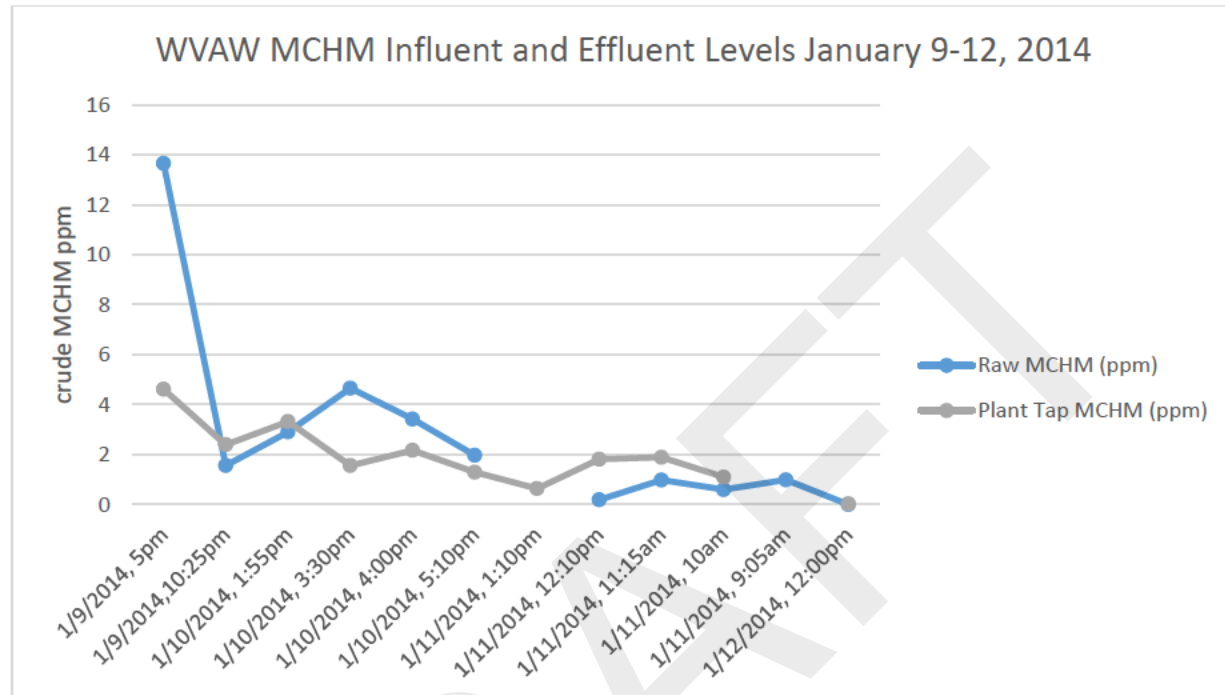
on January 9, water entering WVAW contained levels of MCHM measuring 13.7 ppm in the raw influent (river water) and 4.6 ppm after treatment at the plant tap (final product). On January 10, at 12:30 AM, water testing showed MCHM in the raw water at WVAW measuring 1.04 ppm and 3.35 ppm, but in the outgoing water at 1.02 and 1.56 ppm, respectively (Figure 30).

Figure 30. MCHM levels in influent (river water) and finished water (final product) at WVAW KVTP on January 9-12, 2014.
