U.S. CHEMICAL SAFETY AND HAZARD INVESTIGATION BOARD

# INVESTIGATION REPORT

## CHEMICAL SPILL CONTAMINATES PUBLIC WATER SUPPLY IN CHARLESTON, WEST VIRGINIA

FREEDOM INDUSTRIES, INC.  
CHARLESTON, WV  
JANUARY 9, 2014

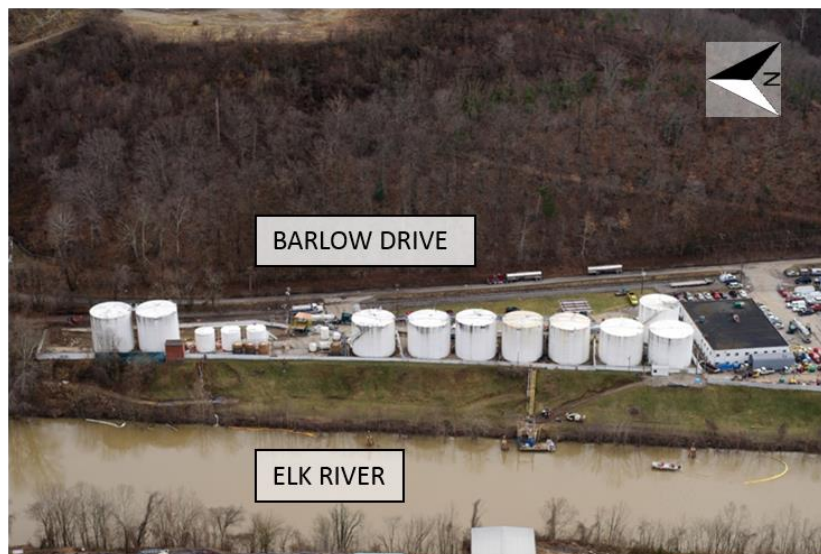
**Figure 2. Etowah River Terminal located between Barlow Drive and the Elk River. (Source: CSB)**

Dating back to the late 1930s, the site stored a variety of chemicals in ASTs under multiple owners and operators. The property is bordered to the north by a wooded area. To the east of the site is a railroad corridor and Barlow Drive. A steep wooded slope is located beyond Barlow Drive (Figure 2).

Residences are located immediately south of the site, while the Elk River is located along the western border.<sup>38</sup> Elk Refining Company was the original owner of the facility and purchased various acreages of land between 1938 and 1947. Over time, varying sizes of ASTs were added as the facility grew. Prior to ERT's ownership of the site, it was owned by Pennzoil-Quaker State (PQS) (formerly known as Pennzoil United, Inc.). PQS sold the land and equipment to ERT in 2001.<sup>39</sup>

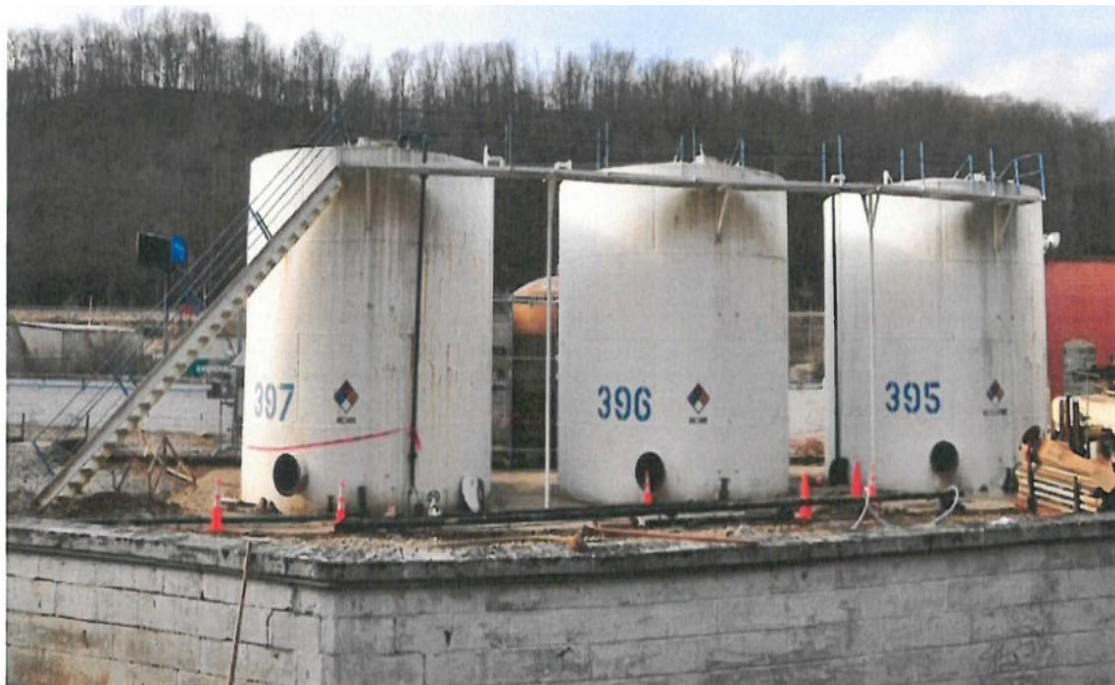
**Figure 4. MCHM- and PPH, stripped-containing tanks at Freedom post-incident. (Source: CSB)**

Tanks 395, 396 and 397 were 20 feet in diameter by 20 feet tall. The tanks had a lap-riveted<sup>46</sup> shell, cone roof and a 0.25-inch lap-welded<sup>47</sup> bottom. Tank 397 was a blend tank that was used to mix Crude MCHM and PPH, stripped to produce ShurFlot 944.<sup>48</sup> The final product was stored in tanks 396 and 397 as well as in totes for sale (Figure 5).

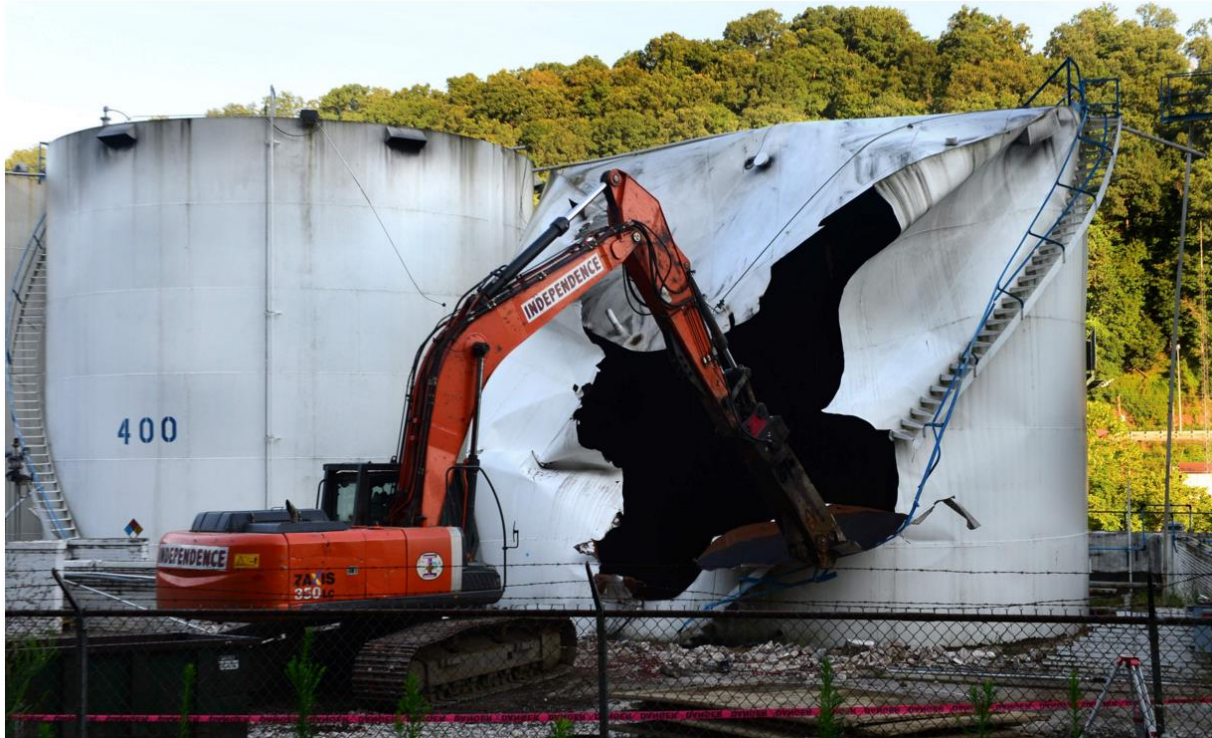
**Figure 7. Demolition of the tanks at Freedom. (Source: Charleston Gazette)**

By January 11, 2014, Freedom had removed all of the tank contents from the ASTs and transported it offsite to Poca Blending, LLC in four large tanker tanks.<sup>63</sup> On January 17, 2014, Freedom filed for bankruptcy with the U.S. Bankruptcy Court Southern District of West Virginia. On January 24, 2014, WVDEP issued a consent order to Freedom to dismantle and manage removal of all ASTs, associated piping, machinery and equipment associated with the bulk storage operations at ERT. A tank decommissioning plan dated March 7, 2014, and a companion remediation plan dated March 17, 2014, were prepared, which WVDEP approved. Tanks 393 through 402 were demolished, while tanks 403 through 405 were used for water runoff monitoring and storage compliance with the WVDEP Consent Order. The onsite buildings, including the office, garage and storage facility, were not demolished. The retaining walls and retention areas remained intact so that no contamination of areas from tank 396 occurred during the demolition.<sup>64</sup> Today, the Freedom site no longer has any tanks on the facility and only the office/warehouse, garage and storage buildings remain (Figure 7). Freedom entered into the Voluntary Remediation Program in late February 2015, and the land has undergone extensive remediation since then (Figure 8). See Appendix B for a summary of fines and charges to Freedom officials.

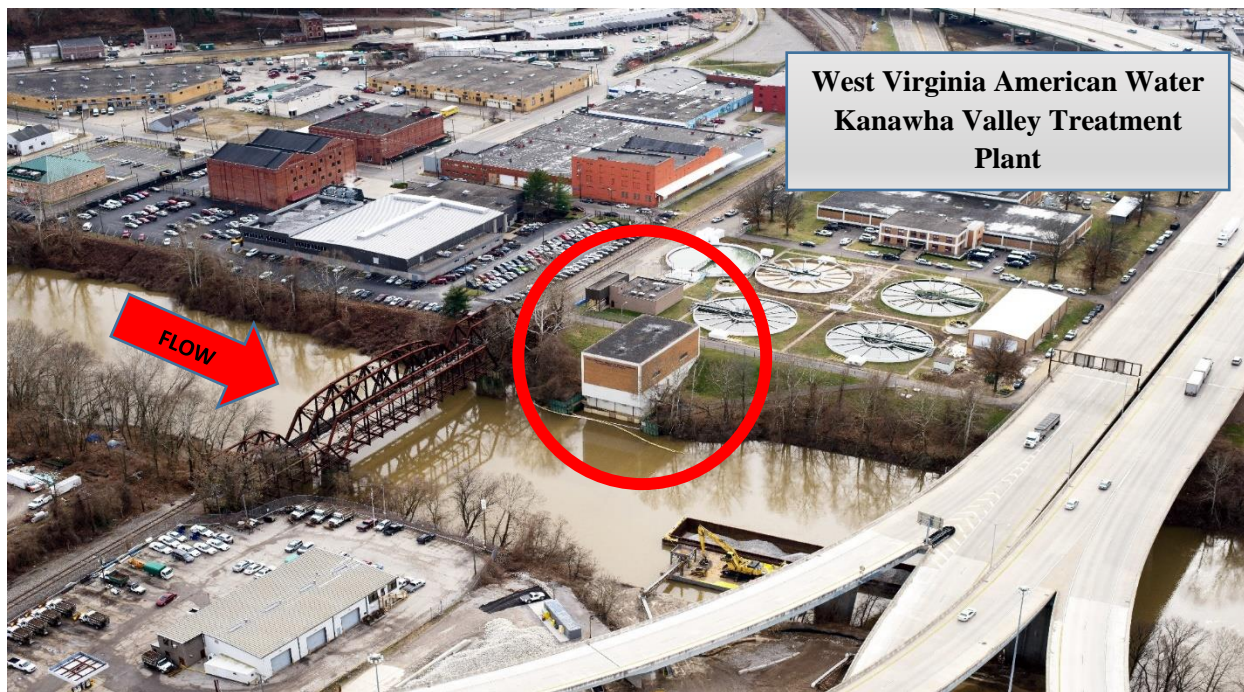
**Figure 9. Location of the WVAW water intake along the Elk River. (Source: WVAG)**

The Freedom facility is located approximately 1.5 miles upstream from the raw water intake of the WVAW<sup>65</sup> Kanawha Valley Treatment Plant (Figure 9).

When WVAW KVTP was being designed, company officials initially proposed, to the Public Service Commission (PSC), to consolidate three existing water systems and to use two intakes—an existing one on the Elk River upstream from Freedom and a new one on the Kanawha River. The intake on the Kanawha River at Chelyan was denied by the West Virginia Department of Health<sup>66</sup> in a permit issued on March 27, 1969, because Kanawha River water was not suitable for drinking. On August 15, 1969, after submitting revised plans, WVAW was approved by the Department of Health for a new single river intake on the Elk River at the new treatment plant site.

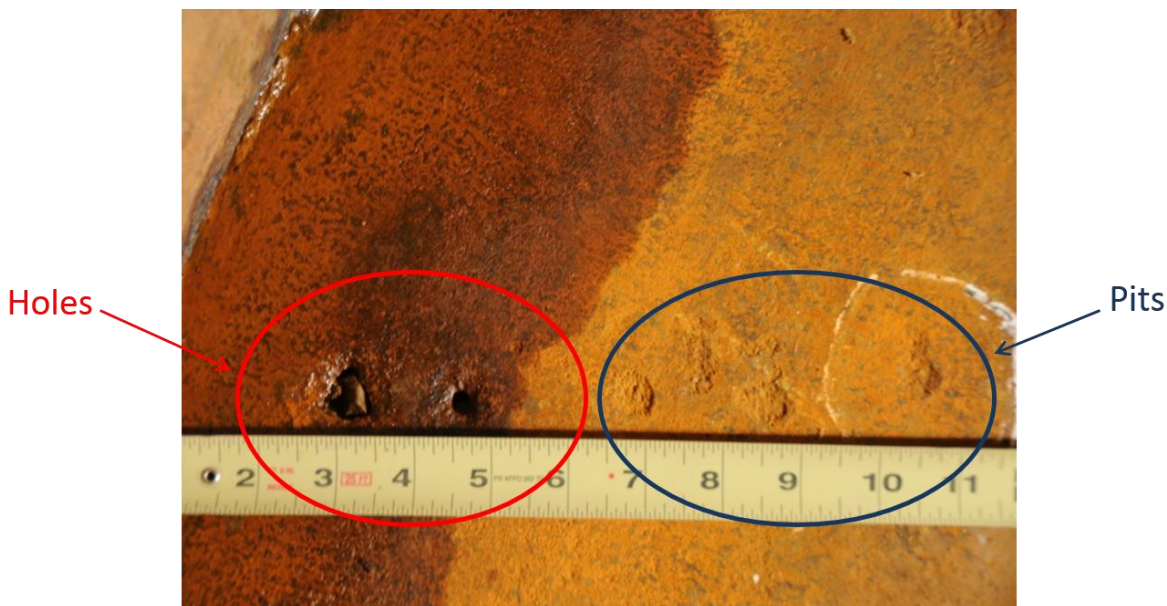
During a visual inspection of the bottom interior of tank 396, inspectors identified deep, isolated pits or crevices near the shell (side) of the tank in addition to two holes on the tank floor (Figure 13).<sup>95</sup> CSB determined that the two holes, approximately 0.75 inches and 0.4 inches in diameter, were the source of the leak (Figure 14).

Figure 13. The bottom of tank 396 with holes and pits identified. (Source: CSB)

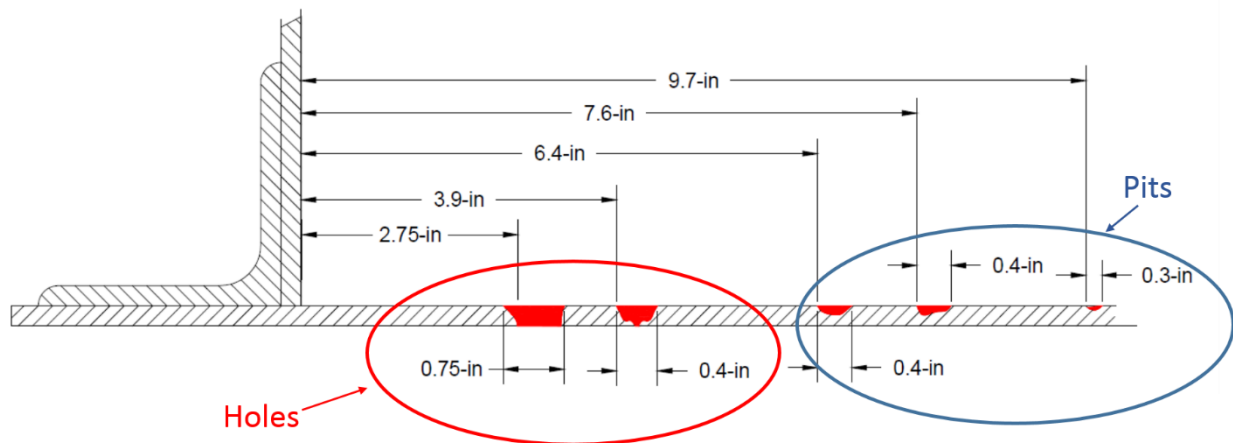
Figure 14. The bottom and shell wall of tank 396 with holes and pits identified through floor thickness. (Source: Powers<sup>96</sup>)

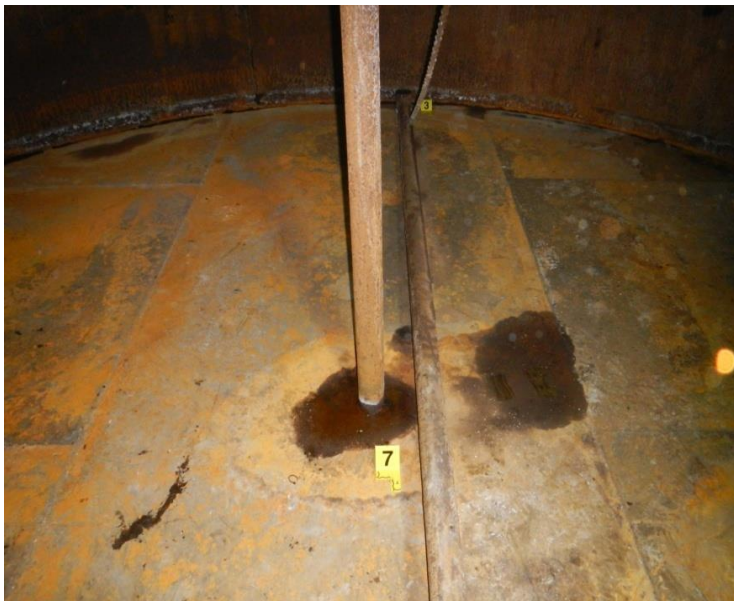
replacement bottom of tank 396 was a welded construction using lap-welded bottom plates, which suggests the bottom was retrofitted sometime after 1945 (Figure 16).<sup>118</sup>

**Figure 16. Retrofitted welded bottom of tank 396 (inside of tank). (Source: CSB)**

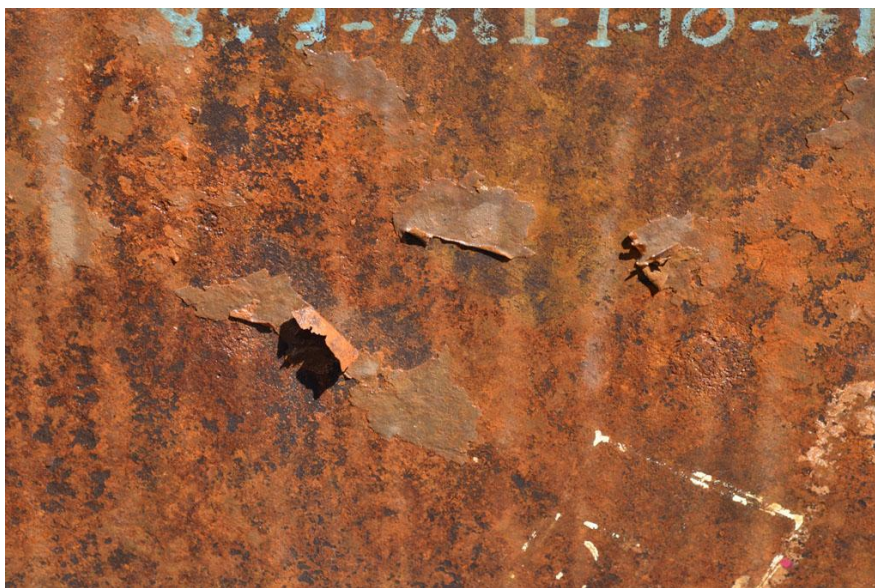
During the initial examinations prior to dismantling tank 396, inspectors noticed remnants of what could have been a flexible organic liner or patch, adhered to the interior surface of the tank floor, likely applied sometime before the leak occurred (Figure 18).<sup>120</sup> Analytical testing determined that the chemical composition of the material was PVA.<sup>121</sup>

Figure 18. Remnants of coating on interior tank floor. (Source: Anamet<sup>122</sup>)

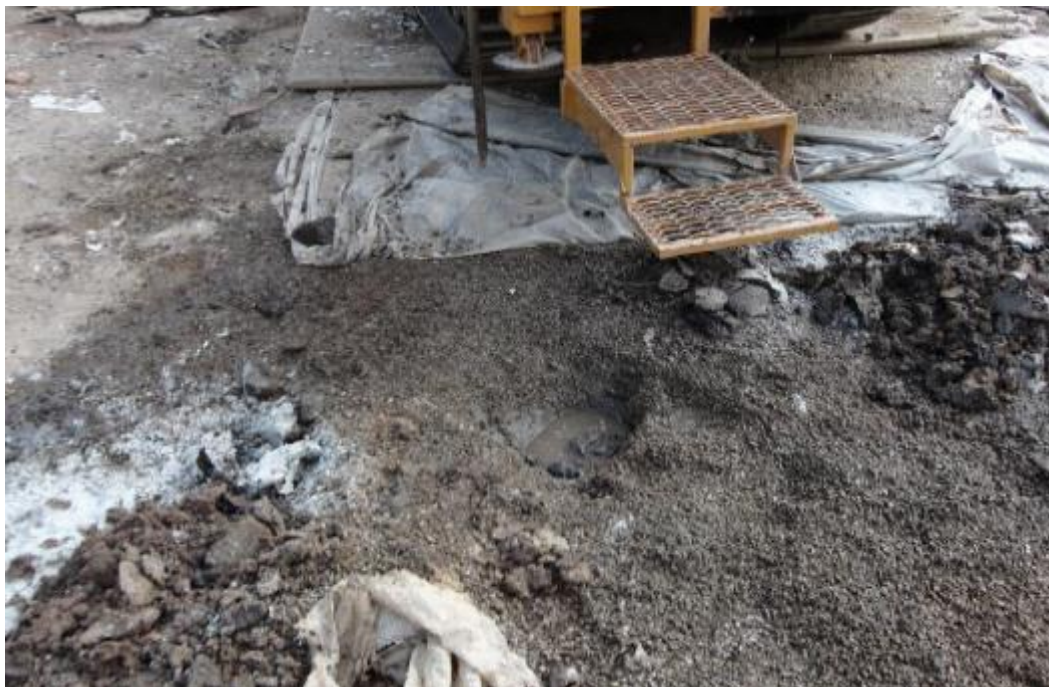
**Figure 20. Gravel base under tank 396 and other tanks containing mixtures with Crude MCHM and PPH, Stripped.**  
(Source: Terracon)

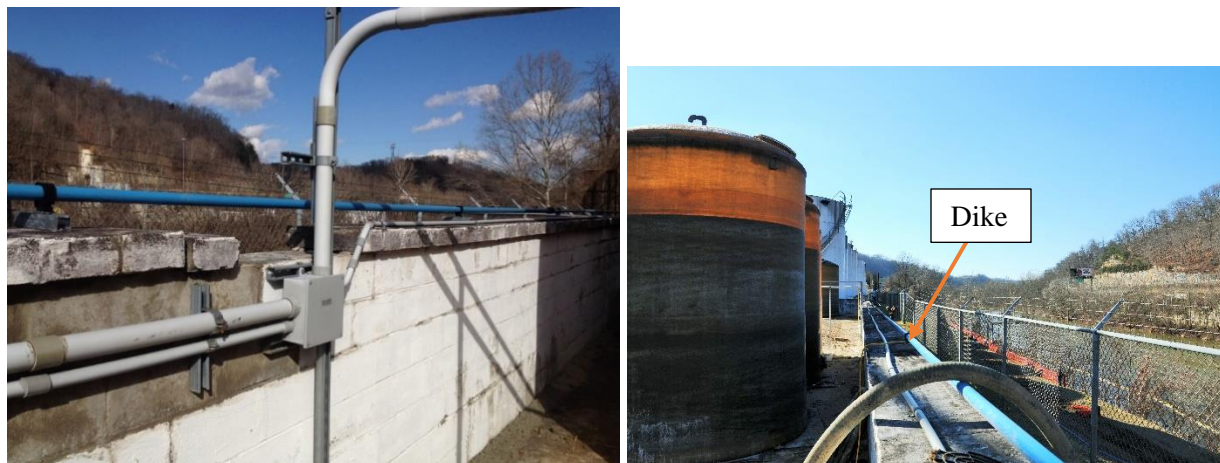
**Figure 23. View from inside the dike wall facing the Elk River of the concrete block walls with no reinforcement (Left); dike wall along the tank farm parallel to the Elk River (Right). (Source: CSB)**

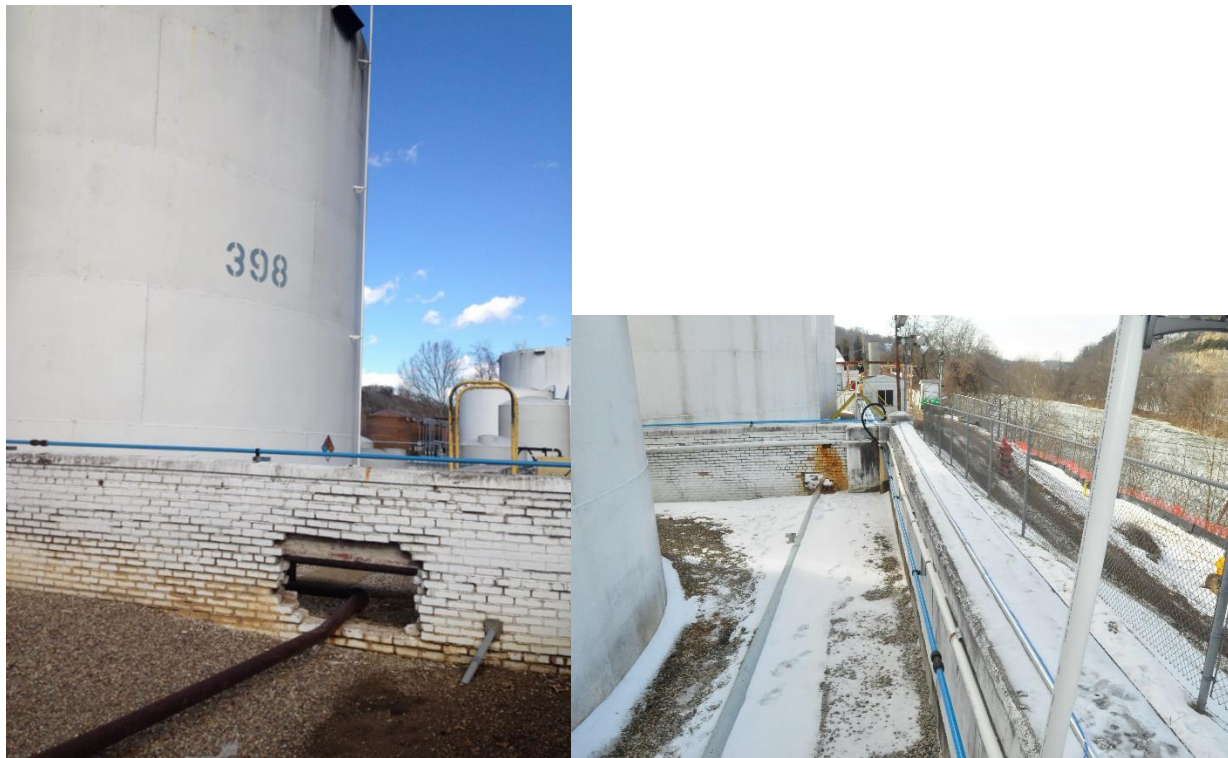
addition, although concrete caps were used around the top of the dike walls, many of these caps were missing or had deteriorated, which allowed for rainwater or other elements to infiltrate the walls.

**Figure 24. The dike walls that surrounded the tank farms were in poor condition. (Source: CSB)**

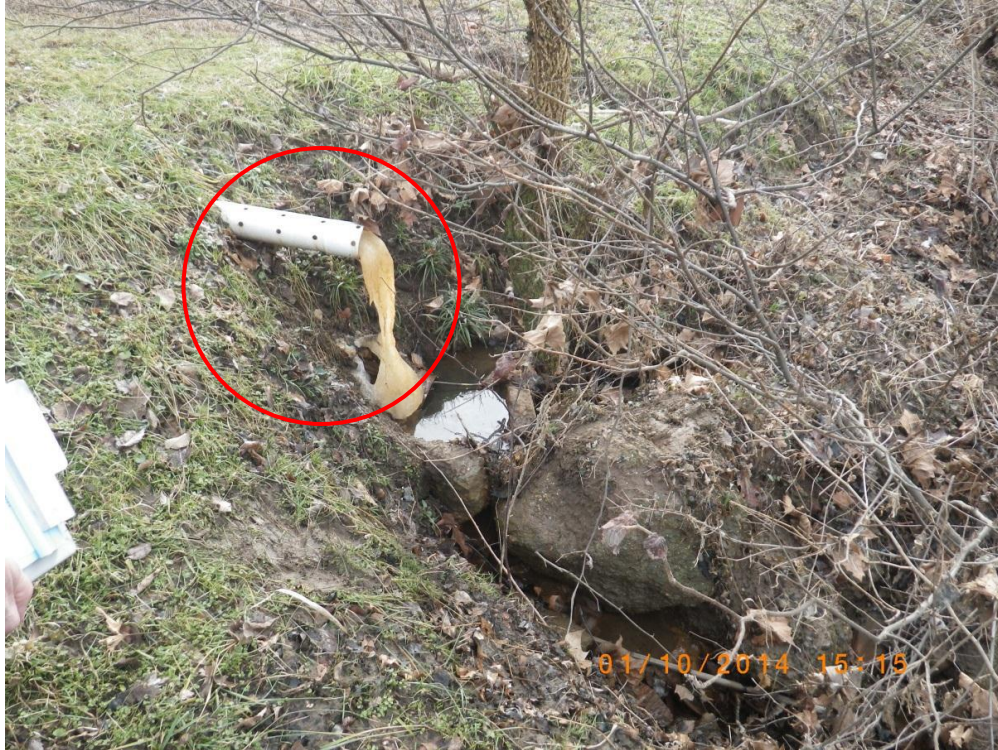
**Figure 25. Ice-filled oil/water separator discharge pipe into the Elk River. (Source: WVDEP)**

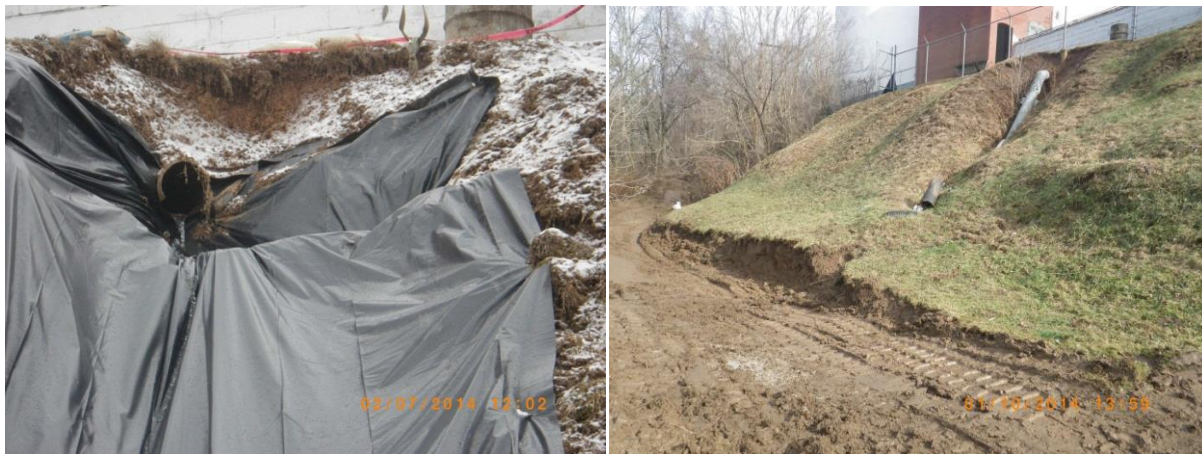
Figure 27. Water flowing through a corrugated steel culvert extending from the hillside (Left); stormwater pipe above interceptor trench (Right). (Source: WVDEP)

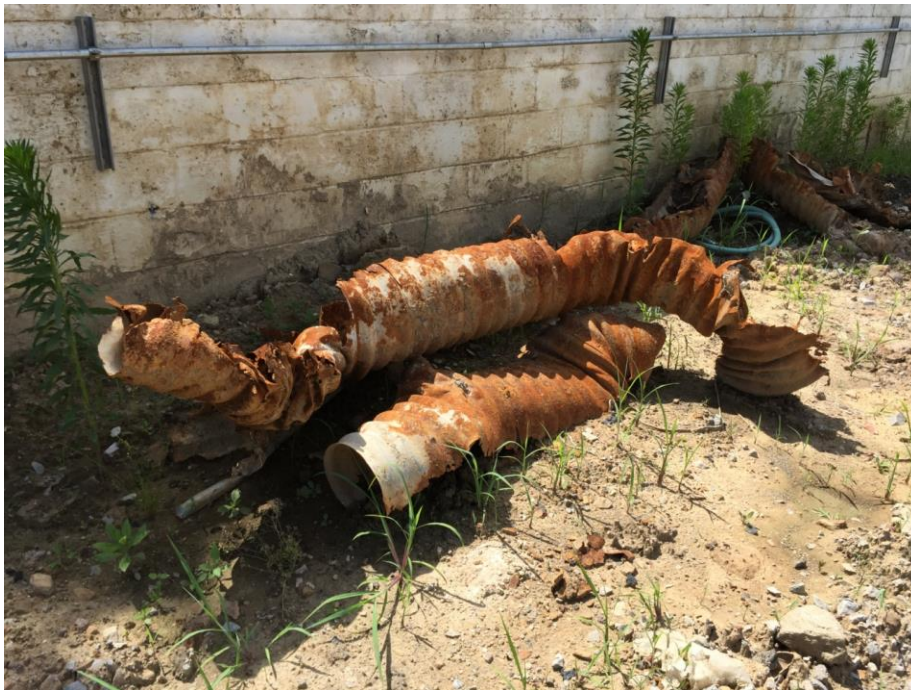
**Figure 28. Photo taken on June 15, 2015, of remnants of the culvert that ran between tanks 394 and 395 beneath the site. (Source: CSB)**

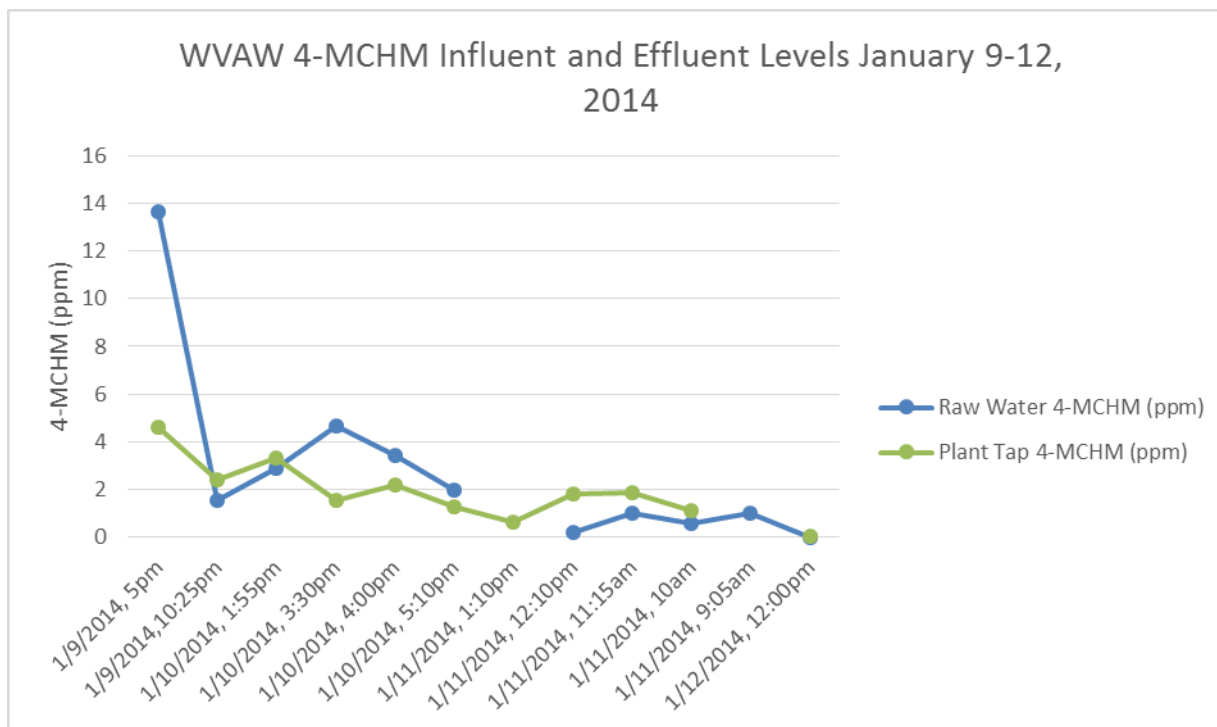
Figure 30. 4-MCHM levels in influent (river water) and finished water (final product) at WVAW KVTP on January 9-12, 2014. (Source: WVAW)
